RE: Arlington Parks Playground Assessment and Recommendation Report

PLAYGROUND ASSESSMENT AND RECOMMENDATION REPORT

PLAYGROUND NAME & ADDRESS: Buzzell Field, 29 Summer Street

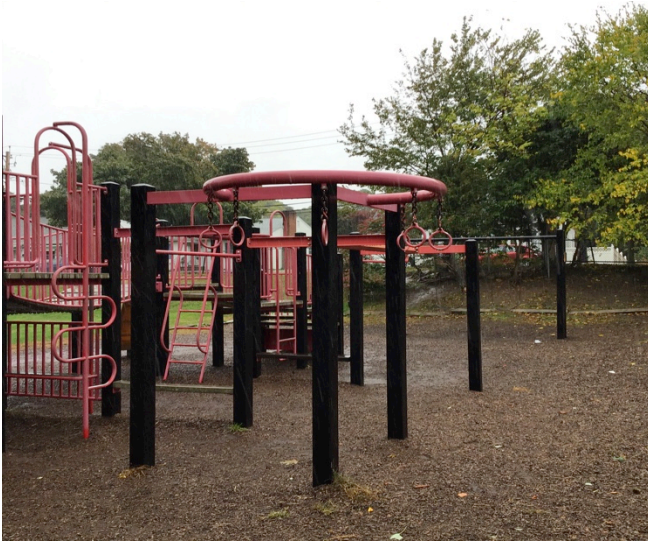
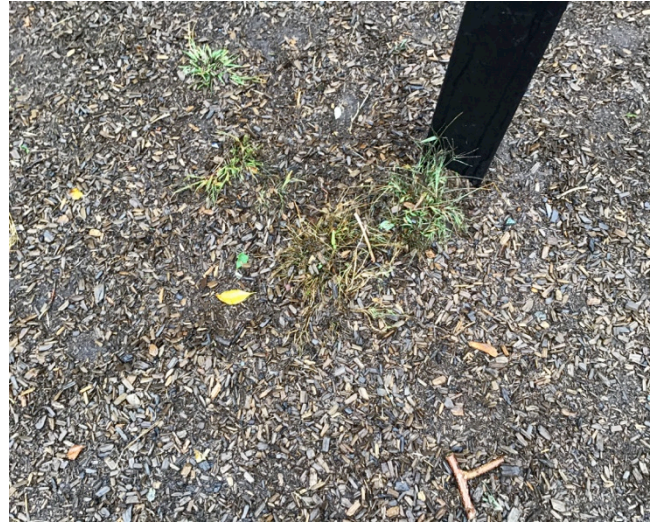
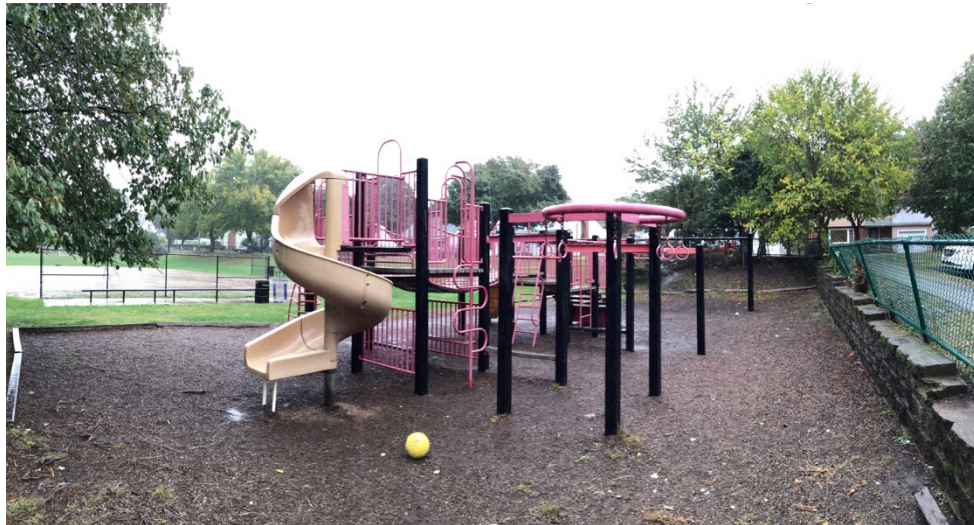
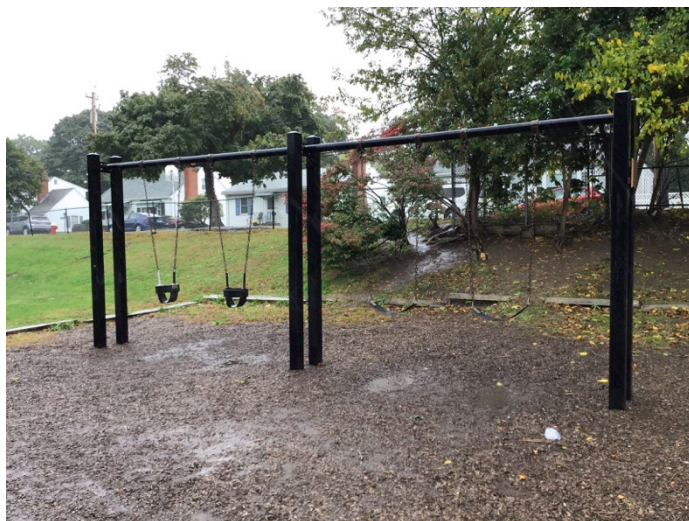
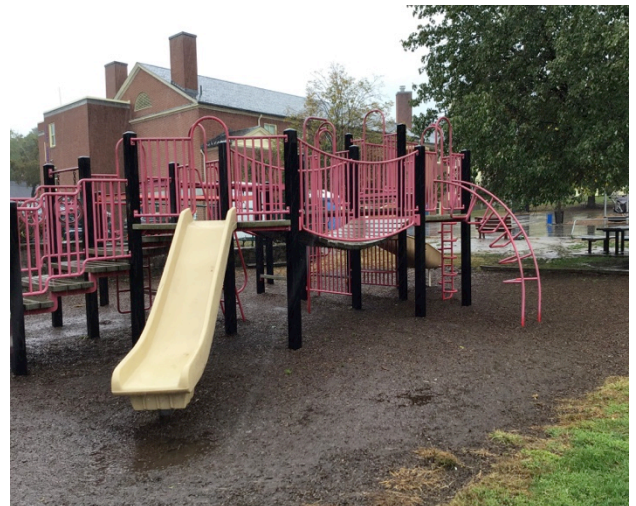
The lack of surfacing [none] creates a hazardous situation; which is enough to recommend this playground be closed. This includes the swing area [remove the swing seats]. This area has zero impact attenuation. If the school currently uses this playground, I recommend closing it off from their use. In addition, what little surfacing there is, does not drain. It is hard to tell where or if any resilient surfacing may have been.

The main frame of the structure is in good condition. The manufacturer, Playground Environments is 'out of business'; therefore retrofitting of needed parts is not an option.

- Due to a newer playground adjacent to this site, it would not be cost effective to retain this equipment.
- Consider this site for a future playground for aged 2-5 years.
- Remove the swings.
- Address the hazards and do not retro fit with parts from another manufacturer.
- Review drainage.

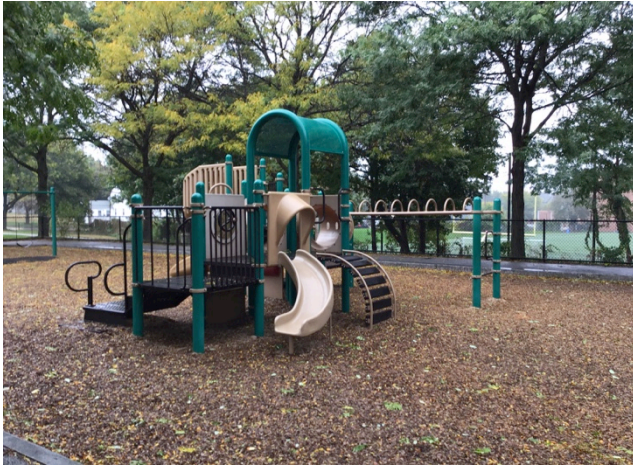
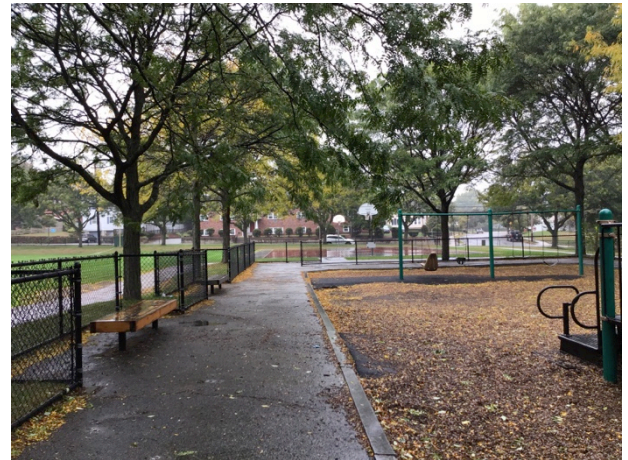
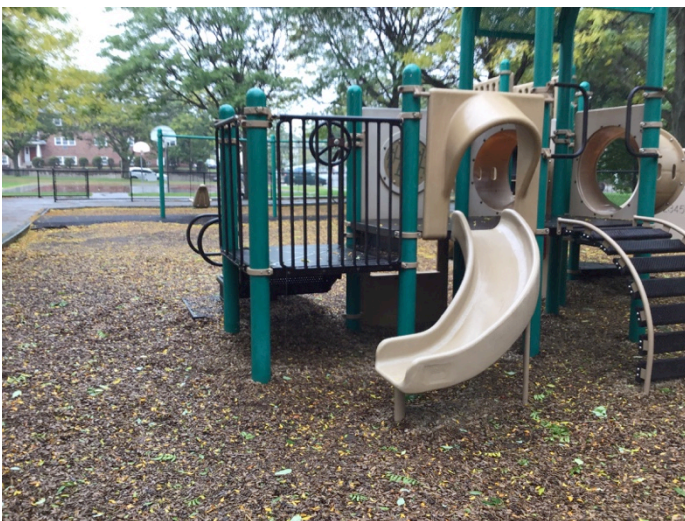
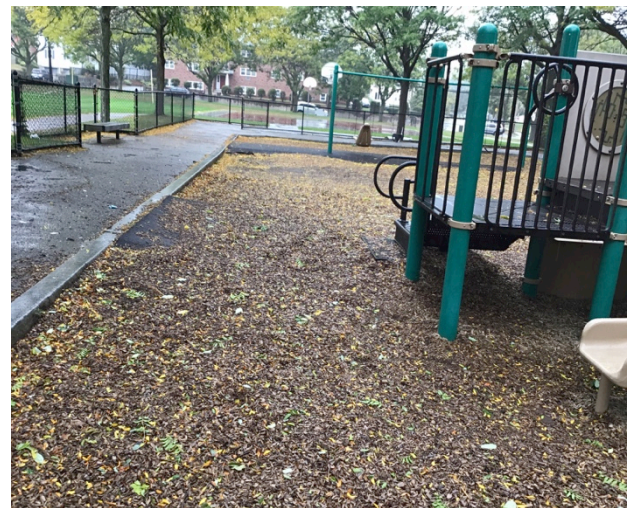
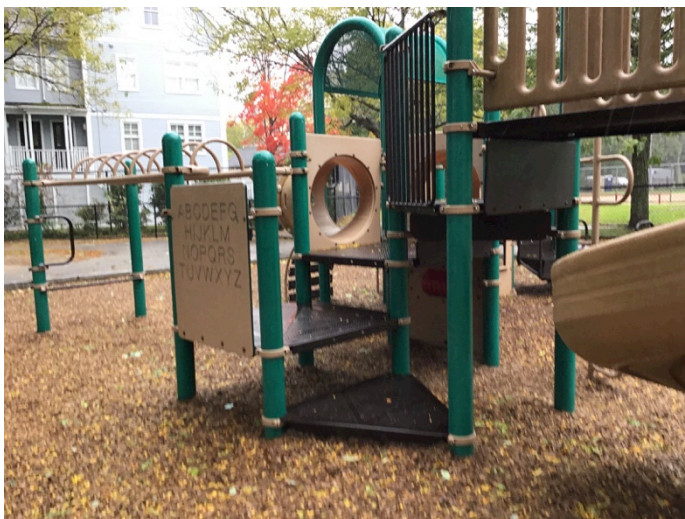
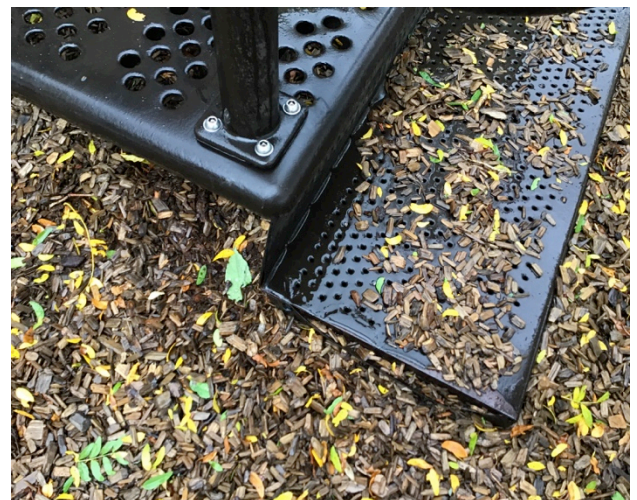
The swings are in poor condition and are being vandalized. The swing beams and all hardware need replacement. The beam connector to hardware is not a standard swing hanger/collar. They are welded to the beam and are being compromised.

- Additional EWF is needed. Consider the wear mat product [grass mats] that can be easily installed over the EWF.
- Retrofit non-compliant equipment.
- Trees need to be pruned.
- Retain swing posts only.
- New swing beams and all hardware needed for the same.

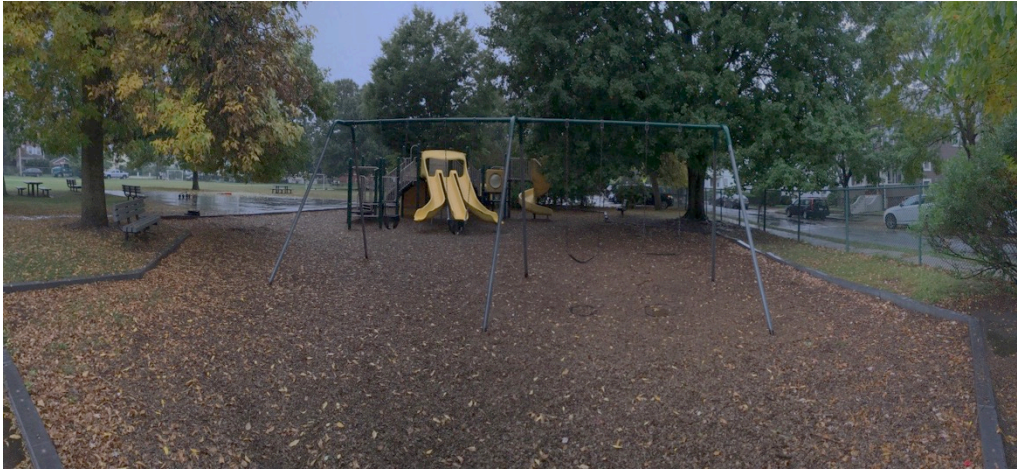
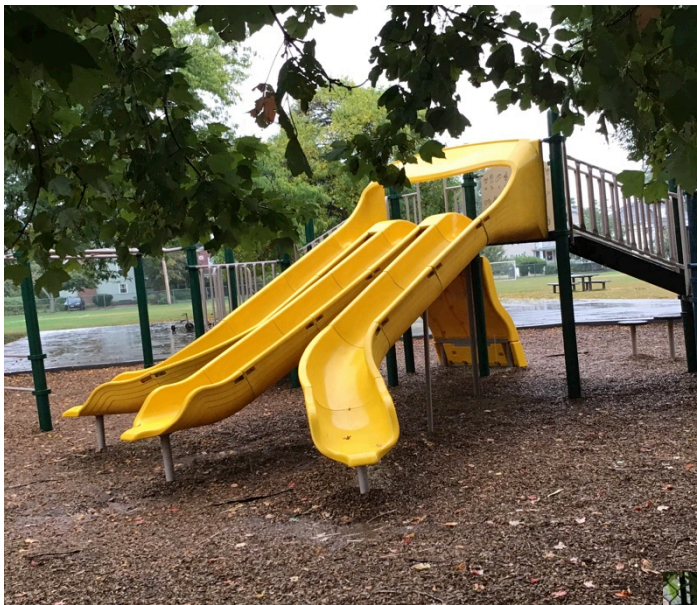
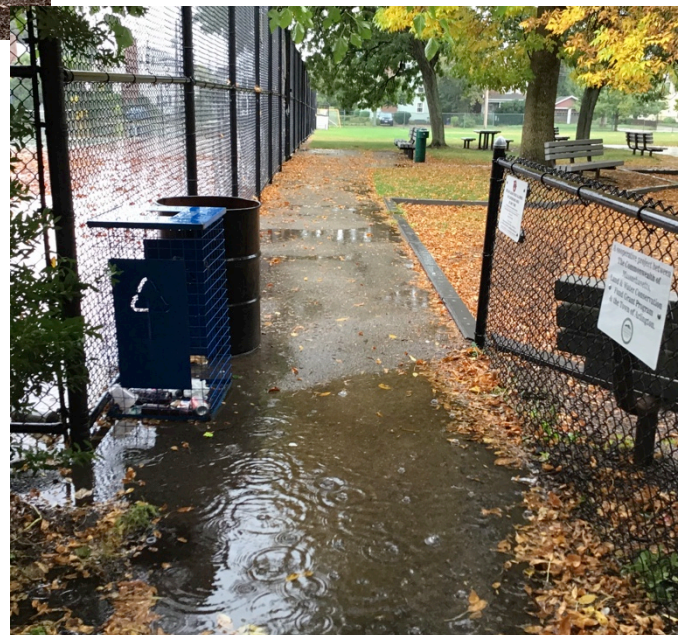
The surface is EWF and is in poor condition; it needs raking and additional EWF. Wear pads are needed under all high use areas [swings and slides]. I do not recommend unitary materials at this site. The cost of the PIP will exceed the worth of the equipment and the PIP will outlast the equipment.

This structure is in fair to good condition. A chain ladder needs to be replaced.

The swings are in good condition – but the lack of surfacing needs to be addressed, as well as the addition of wear pads. The site furnishings are also in good condition.

- Do not consider PIP/unitary surfacing at this time.
- Cut all trees back and up to at least 84".
- Replace all hardware on the swings.
- This site would be a good area to consider 'grass mats' due to the rectangular shape of the area.
- Verify if the school uses this site.

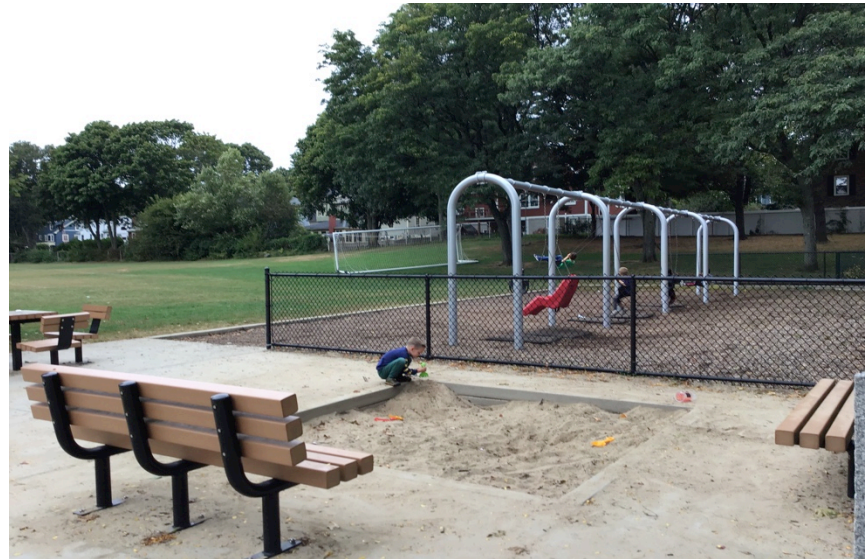
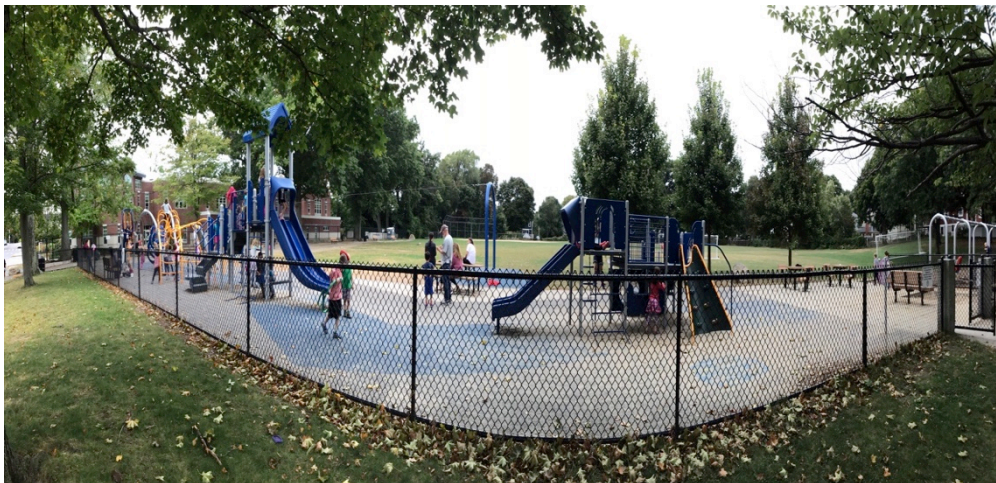
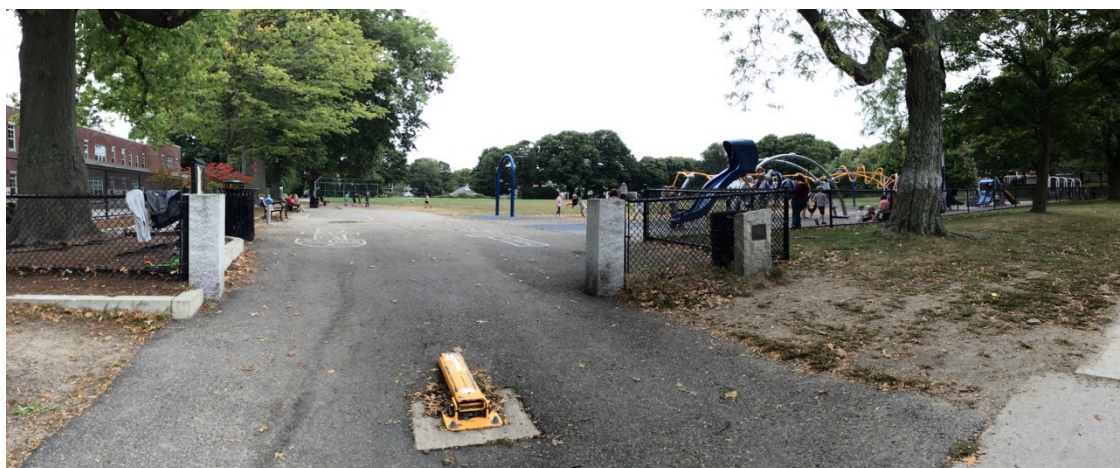
The surfacing is EWF and PIP. The PIP is in good condition. The EWF is in poor condition and has not been maintained. Although there are wear pads under swing seats, they are not in the proper place, thus there are gullies. The track ride has EWF and PIP surfacing. Additional EWF is needed by the track ride. If the track ride was intended to meet ADA, it is not due to the drastic sloping. The first bay of swings needs a unitary surface to meet MAAB. A sand box is within the playground, and due to this, there is sand strewn on the PIP surfacing; the sand will rub off the EDPM top layer of the PIP.

The equipment is in very good condition. In my professional opinion, while compliant, this was a poor design with a slide exiting into another slide. The wiggle ladder is the incorrect size and is rusting. Moving

Swing frames and clamps are in good condition. Moving parts and chains need to be replaced and should now be a month-to-month review for wear. The sand from the sand box is everywhere and is slippery when rubbing with the PIP. You may want to consider a better type of box, or a cover to retain the sand.

- Maintenance to be more frequent, as this is playground is also used by the school.
- Standardize trash receptacles with liners and tops to keep animals out. The 55 gallon drum should have a top due to the proximity of the playground.
- Replace the wiggle ladders.
- Although the playground is 'newer', it has a heavy user base including the school and afterschool programs.
- There are minor needs for the next 10 years with a standard of care that should be put in place.
- The playground is newer and there are many 'voids' in the PIP. I recommend a head drop test be done.

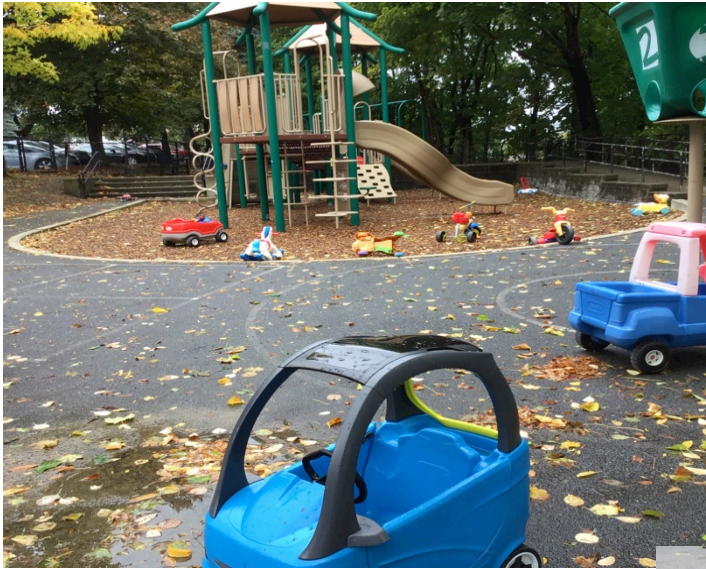
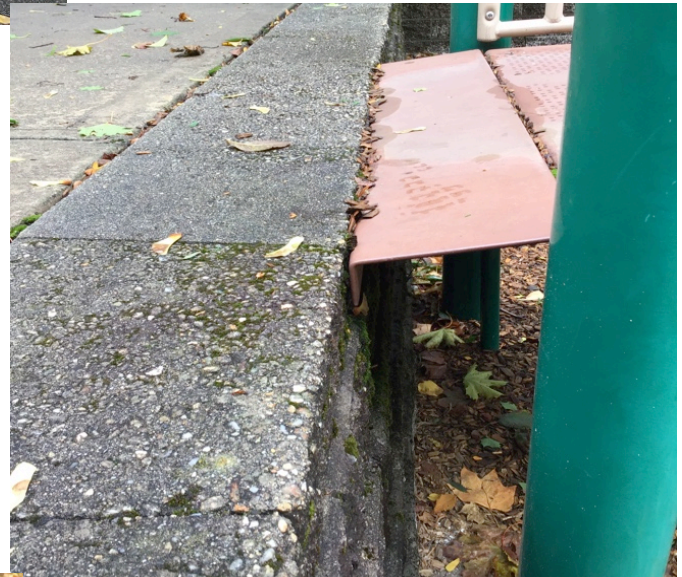
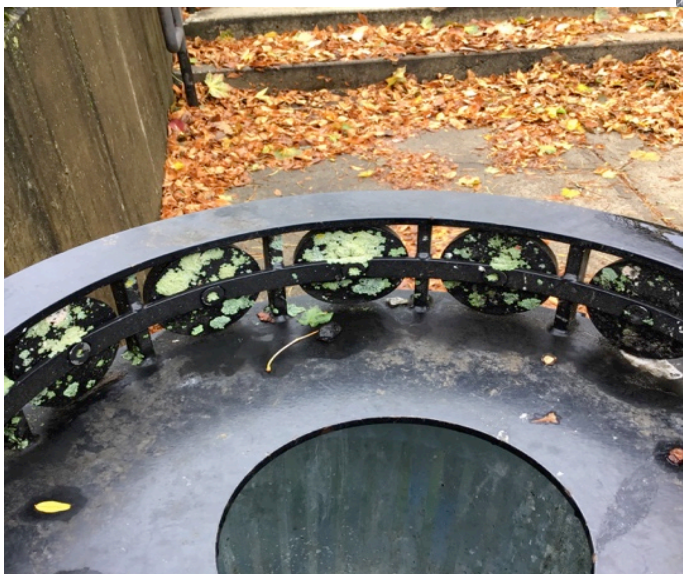
The surface is EWF, and is in poor condition. The surface needs to be weeded and the vegetation should be cut back. Additional EWF is needed.

This equipment is in fair condition and has standard maintenance needs. With this standard maintenance, the equipment should last 5-10 more years. Note: the ramp connector plate for sidewalk to infill is not attached and is free floating. Although there is ramping, an accessible route of travel is needed at grade.

Recommend removal of the 'straps' on the adaptive swing [children have been strangled with these types of straps]. Consider the plastic harness type seat. The belt seats are much too high due to the lack of surfacing. The swing chain needs to be replaced.

- Plan for unitary surfacing, if only to individual pieces. It is not cost effective at this time for PIP. Grassmats would be a good alternative.
- Enhance play opportunities for the 2-5 age group.
- One seat on the table needs to be replaced. Manufacturer is unknown.
- Landscape cleanup and pruning is needed.
- Additional EWF needed.
- Sand, touch up and paint in certain areas.

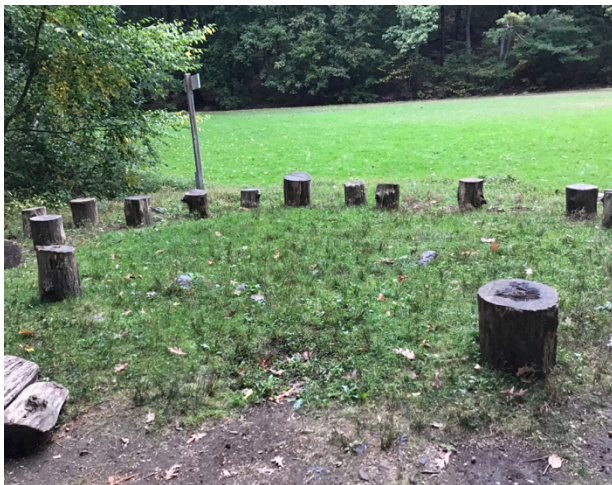
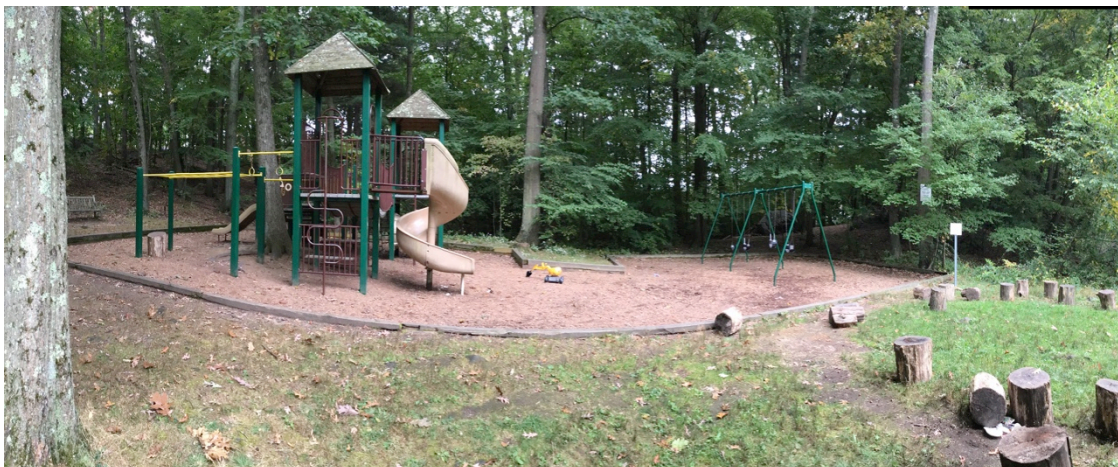
The surface is in poor condition, both in the playground area and in and around the picnic tables. The edging used to retaining surfacing is in poor condition. Animal feces, bagged and unbagged, were in and around the surfacing.

The Manufacturer of this playground is no longer in business. Much of the playground does not comply to current standards. A large tree has grown in the middle of the playground. The playground is age appropriate for 5-12 years, except for the swings – being appropriate for 2 – 12 years. In my professional opinion, there is no value in retaining this playground, it is dangerous, and is in very poor condition.

The swings are out of compliance due to inadequate use zone, hardware and chain status. The hardware cannot be retrofitted. The vegetation next to the swings is overgrown.

- Remove all equipment.
- Remove all logs.
- Remove all site furnishings.
- Change out the existing drinking fountain and add a 'water bottle filler' type, ADA compliant, and also a dog 'drinking' bowl.
- If replaced, a good deal of site work will be needed. Consider the playground be closer to the entrance of the park.

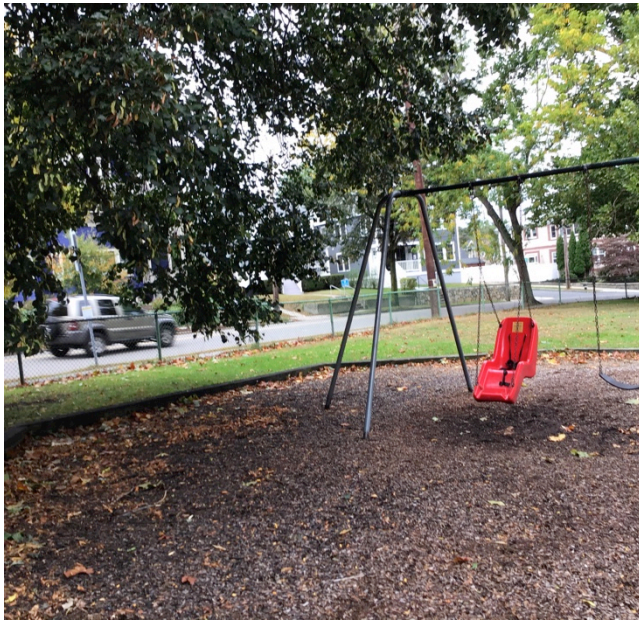
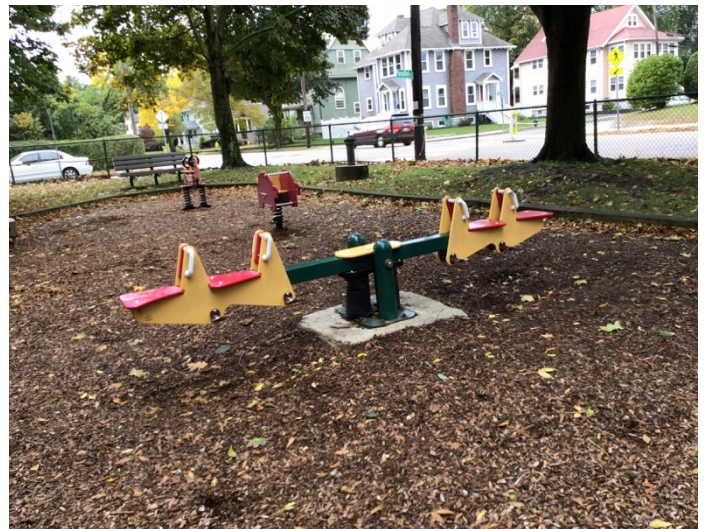
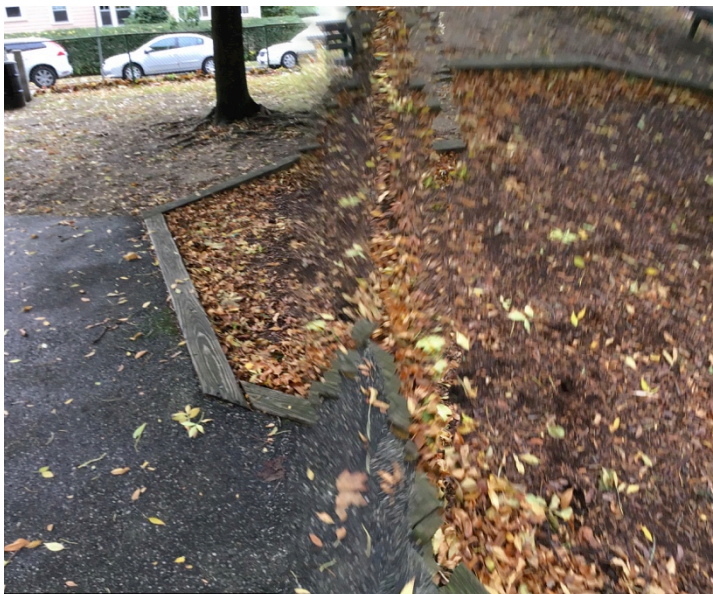
All swings need new hardware and chain. The belt seats needs to be replaced. The spring see saw is broken, and parts are no longer available; suggest to remove.

- Cut back trees to 84"
- Additional EWF needed [after vegetation clean up]
- Change out parts on the swings
- Smaller structure is in fair condition – suggest to retrofit
- Do not consider unitary surfacing material at this time.
- Remove the 5-12 structure and consider installing a unique independent piece/s of equipment. The space is open and this would enhance the value of the park.

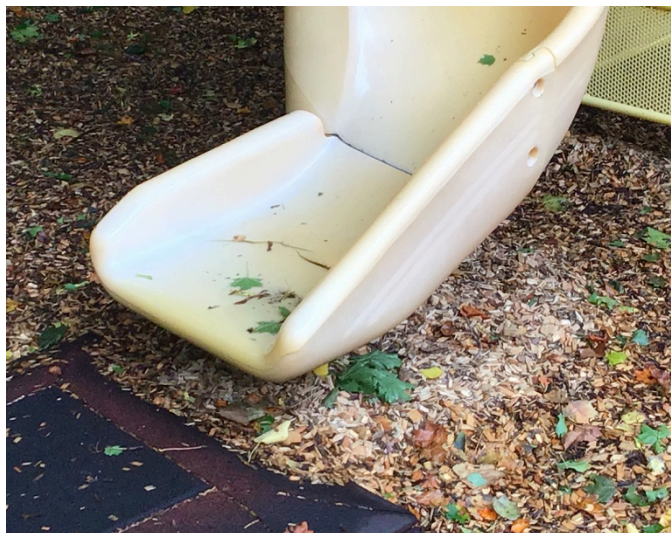
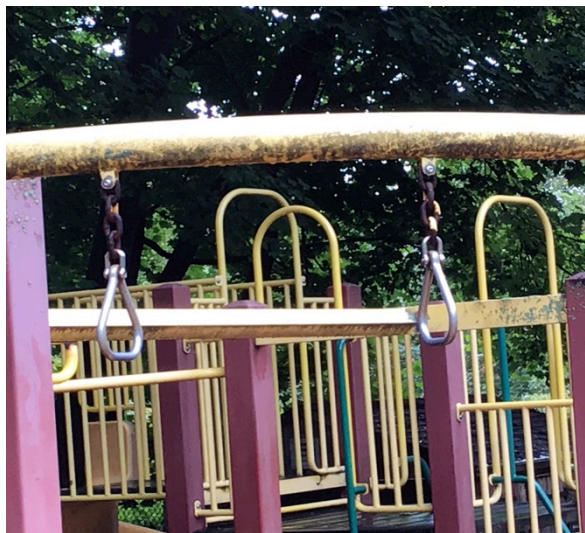
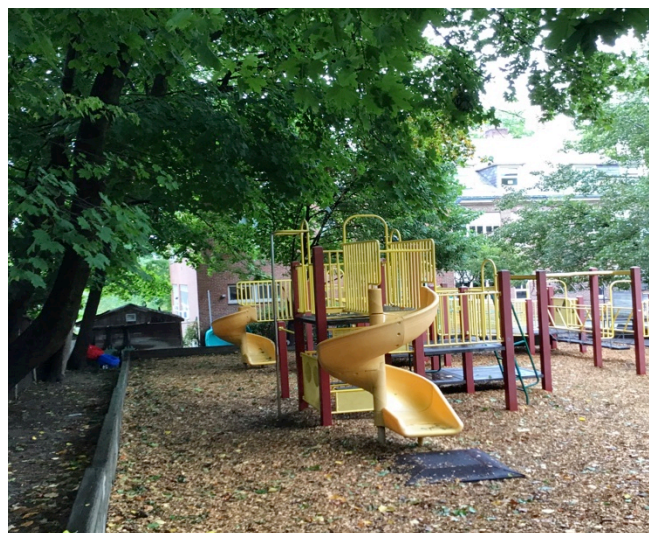
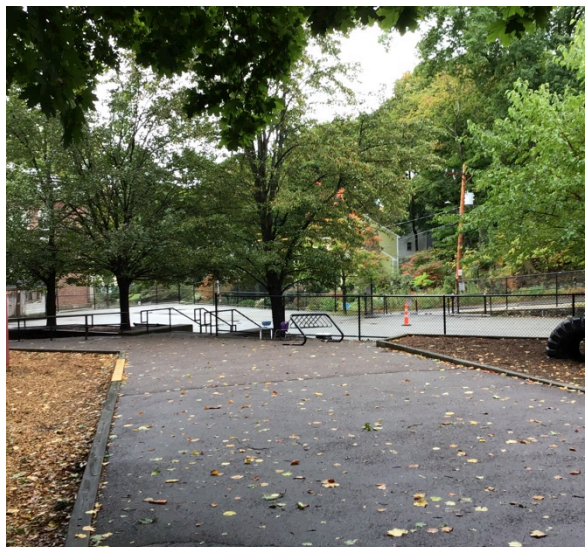
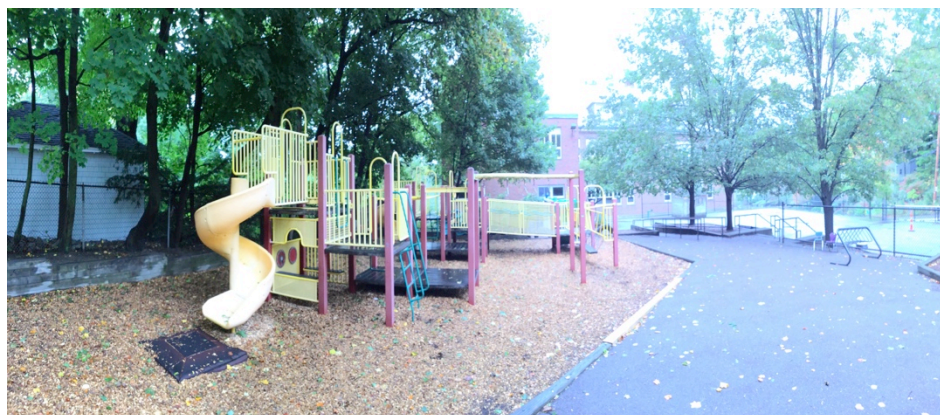
Remove the front spiral slide and board the top now. The slide is cracked and cannot be replaced, as the Manufacturer is no longer in business.

- Remove and replace the links.
- Cut back vegetation.
- If the school uses the playground, they should be aware that the equipment is in 'fair to poor' condition. Efforts may be made to repair the equipment as an interim step.
- If the school does not use the playground, a few independent pieces of equipment could be considered for the future.
- This playground could be on the priority list, but first, the user needs to be identified [school and/or neighborhood].
- If the Pre-K children are using this site, I recommend not allowing them to use the site, as it is not age appropriate.
- In my professional opinion, I suggest to remove and replace the swings with a 5-12 climbing net.

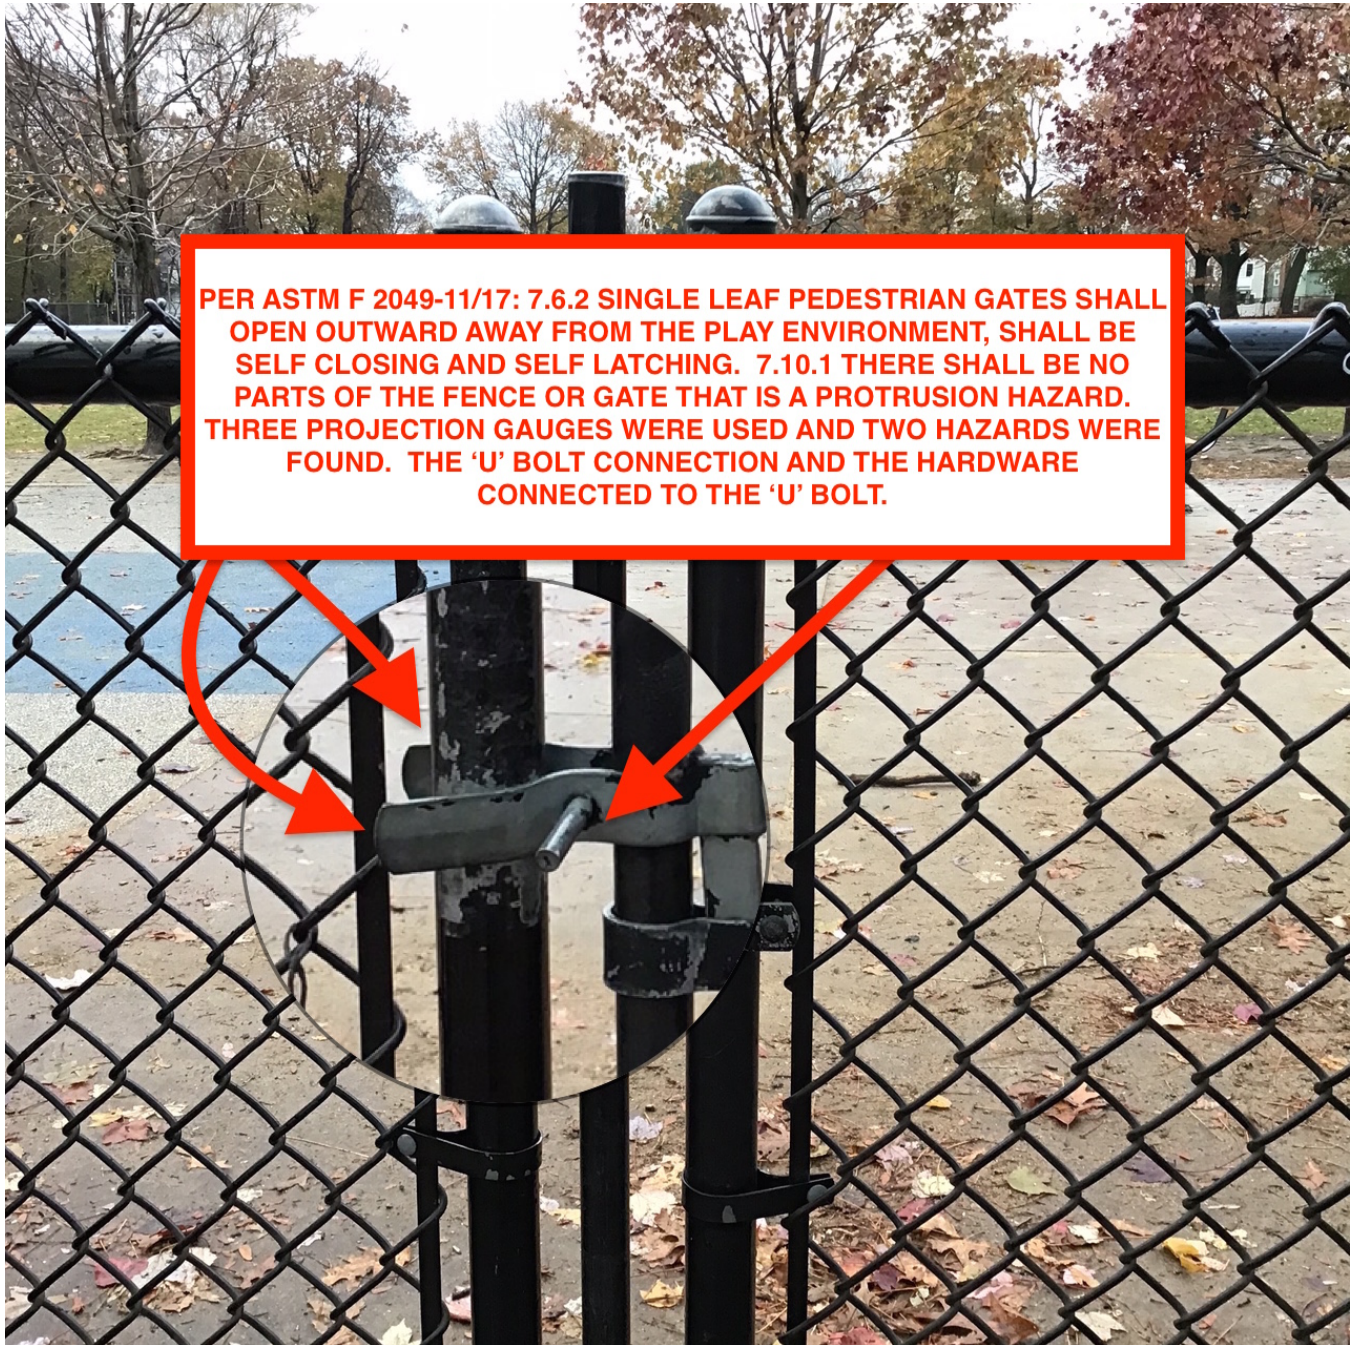
FENCING

PER ASTM F 2049-11/17: 7.6.2 SINGLE LEAF PEDESTRIAN GATES SHALL OPEN OUTWARD AWAY FROM THE PLAY ENVIRONMENT, SHALL BE SELF CLOSING AND SELF LATCHING. 7.10.1 THERE SHALL BE NO PARTS OF THE FENCE OR GATE THAT IS A PROTRUSION HAZARD. THREE PROJECTION GAUGES WERE USED AND TWO HAZARDS WERE FOUND. THE 'U' BOLT CONNECTION AND THE HARDWARE CONNECTED TO THE 'U' BOLT.
